# ***An Evaluation of Detectable Warnings in Curb Ramps: Mobility Considerations for the Blind and Visually Impaired***

**Draft Final Report (Task D)  
"Evaluation of Surface and Audio Tactile Warnings"  
Under R&D Contract  
*INTERSECTION DESIGN FOR NON-MOTORIZED TRAFFIC***

**Submitted to:  
*The Florida Department of Transportation (FDOT)*  
Safety Office**

**September 1995**

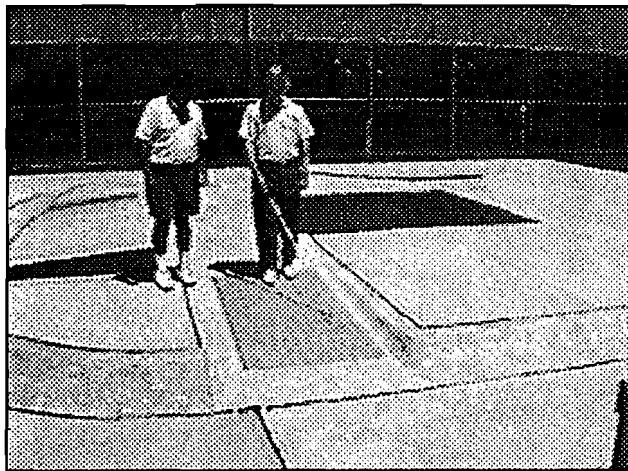
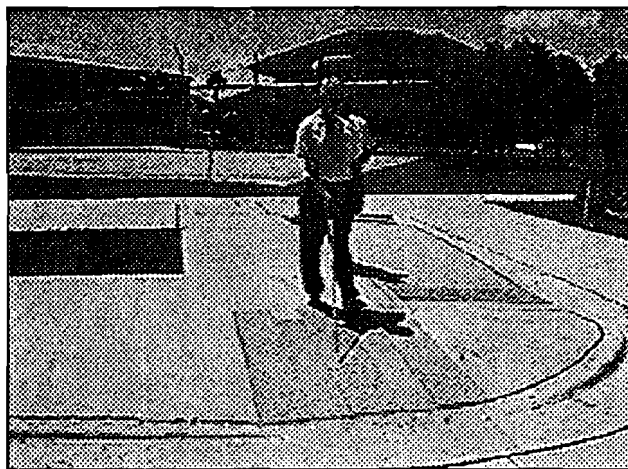
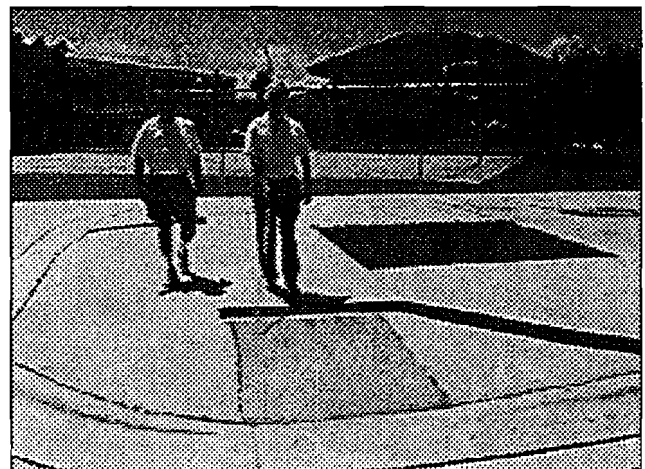
**Figure 11. Cane Users**

When the blind cane user did come into contact with the general ramp area, detection of the tactile warning surface was most likely to occur through initial contact with the cane. Frequently initial cane contact was with the raised edge/side of the tactile warning rather than the top. This seemed particularly true for those having a tendency to keep the cane in more or less continuous contact with the walkway surface. There were however cane users who, despite initial contact with the tactile warning being by way of the cane, reported initial contact being through the sensation underfoot.

Imagery is reproduced from video tape used in data collection. Starting in upper left and moving clockwise, ramps are numbers 1, 4, 8, 2, 5, and 4 (see explanation in text).

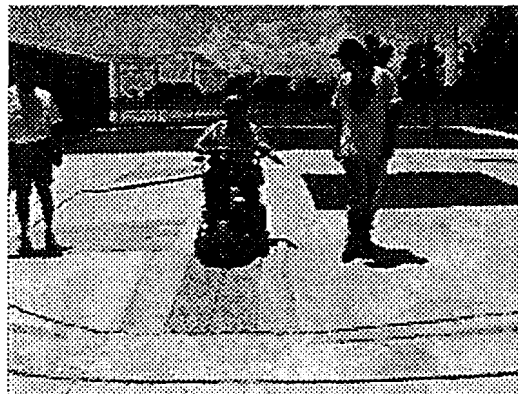
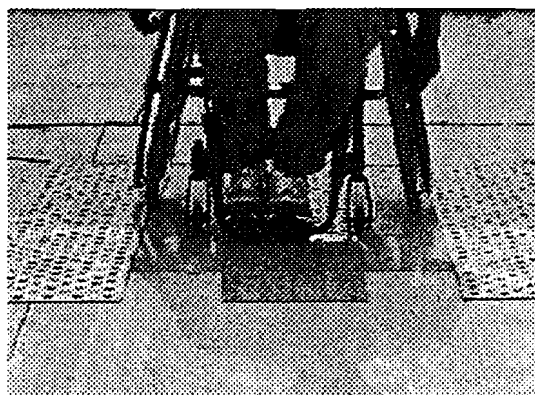
**Figure 12. Wheel Chair Users**

Imagery reproduced from video tape used in data collection. Shown here are ramp treatments intended to minimize resistance caused by surface texture. Beginning in upper left and moving clockwise, ramps are 2, 3, 5, and 5. See text for further explanation of treatments.

d. *Comfort/Discomfort.* While subjects clearly responded to the different sensations produced in crossing the different surface textures, none reported significant discomfort. To the extent that vibration may be related to ones perception of discomfort, the worst condition was the Directional/Bar tiles installed perpendicular to the path of travel. The second most aggressive surface was the Rigid Composite Dome material. These two treatments constituted the most significant impact on vibration and directional control.

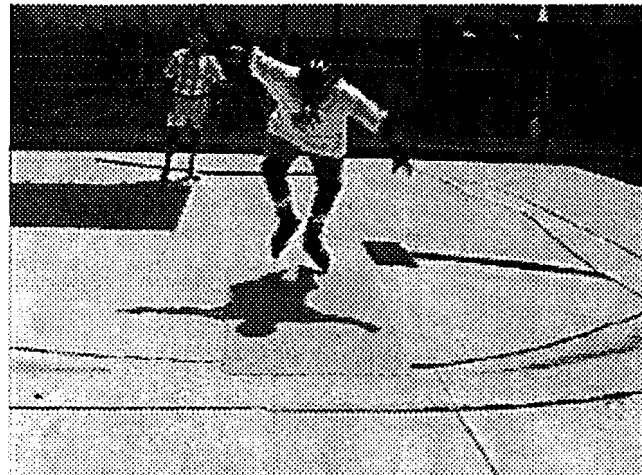
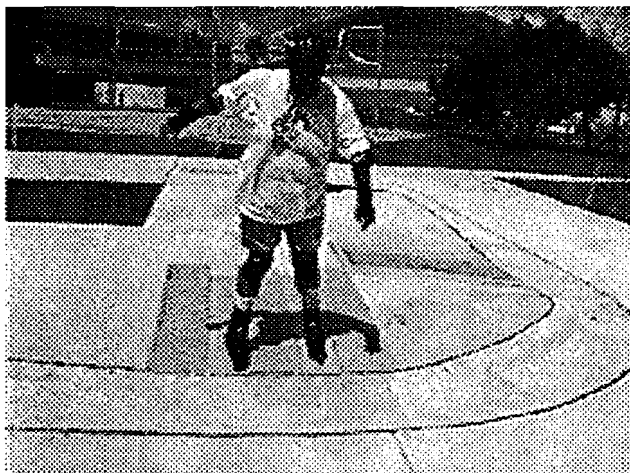
**Figure 14. Roller Blade User**

Imagery reproduced from video tape used in data collection. Pictures show obvious problems for users of in-line skates (roller blades) associated with tactile warning surfaces in curb ramps.

With respect to the effects of tactile warnings on those wearing footwear designed especially for fashion (e.g., high heels) or recreation (e.g., roller blades), there is cause for concern. Our general observation from the Access Board study as well as from observations conducted informally in the local area is that women with heels will generally avoid the ramp area with tactile warnings applied. Our FDOT "heeled subject" when required to walk over each of the designs used in the present study displayed noticeable hesitancy when crossing the material. . . definitely a departure from "normal" walking behavior. Those placements which minimized the tactile warning surface area and which permitted the subject in heels to basically "step over" (otherwise avoid) the tactile surface caused the least problem. Roller blade users need to be advised in ramps where tactile warnings have been applied should be prohibited since such use, according to our observations, is clearly associated with a high probability of falling upon contact.

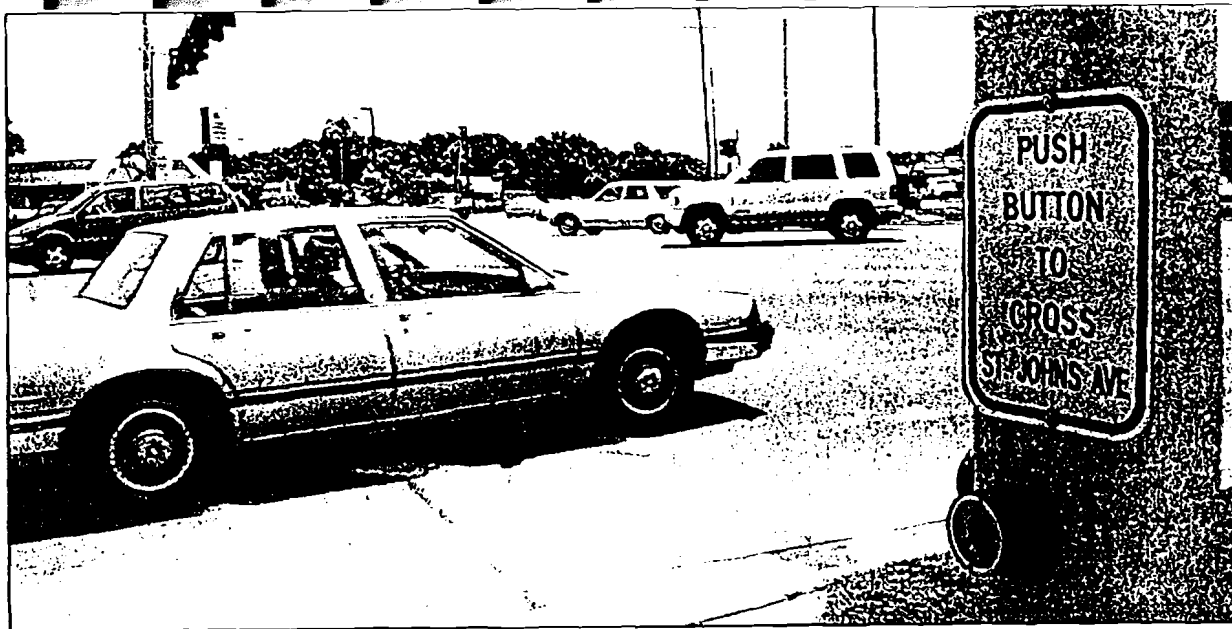
**A pedestrian signal for blind persons has been installed at Highway 19 and St. Johns Avenue.**

When the beeping stops, it does not mean the signal is going to change, but it is unsafe for pedestrians on the sidewalk to start crossing the intersection.
