# Evaluation of an Innovative Application of the Bike Box

PUBLICATION NO. FHWA-RD-00-141

August 2000

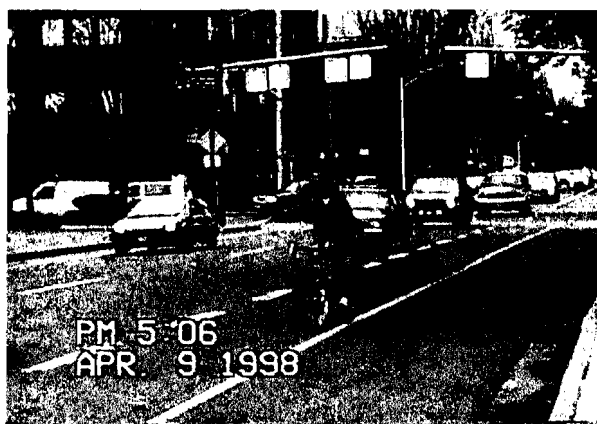
**Figure 4. Bicyclist merging across traffic lanes after the intersection.**

a gap large enough to allow an easy move from the left to the right. Some bicyclists were aggressive and used hand signals to indicate their movement from left to right (figure 4). Many, however, simply stopped in the bike lane and waited for a suitable gap. Besides the crossover from left to right after the intersection identified above (figure 5, Movement 1), there were a variety of other ways used by bicyclists to negotiate this intersection. Some would shift from the bike lane to the motor vehicle traffic lanes prior to the intersection (Movement 2). Others rode or walked their bicycle through the crosswalks on both High Street and Seventh Avenue as pedestrians would, a movement which delays right-turning motorists

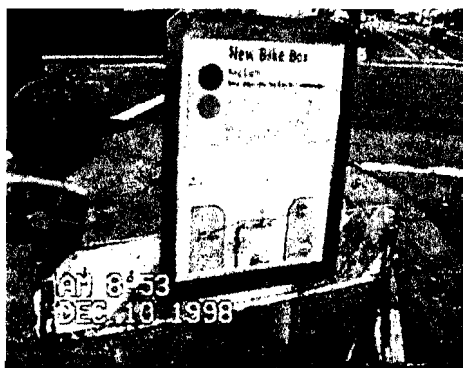
**Figure 7. Educational sign near bike box.**

Several other steps were taken to help bicyclists and motorists understand the use of this innovative treatment at this intersection. A press release was prepared and stories were run in the local newspaper and in the University of Oregon student newspaper. A special sign board with information about how to use the bike box was placed on a construction barricade near the intersection pedestrian crosswalk (figure 7). The barricade with an educational sign also had a flashing light attached.

- Just more than half rode more than 25 mi (40 km) per week.
- While 39 percent correctly indicated that the purpose of the bike box was to enable bicyclists to more easily get from the left to the right side of the street (and another 1 percent said the box was there to get bicycles to the front of traffic), another 59 percent were not sure of the purpose. This prompted the educational sign shown earlier.

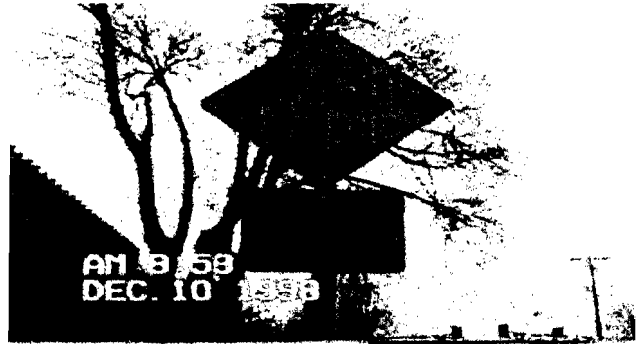
**Figure 9. “BICYCLES MERGING” sign.**

A yellow diagrammatic sign with a BICYCLES MERGING message was already in place (figure 9).

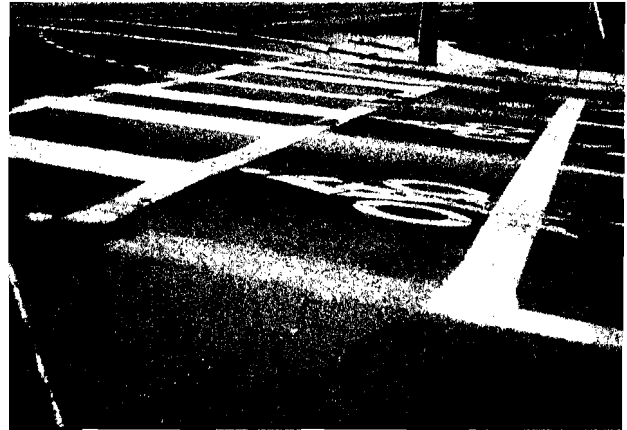
**Figure 10. Smaller first box with lane lines removed.**

The original configuration of the bike box was relatively short in length, about 1.8 m. A standard bicycle logo was placed in the box in front of both the through-lane and through- and right lane (figure 10).

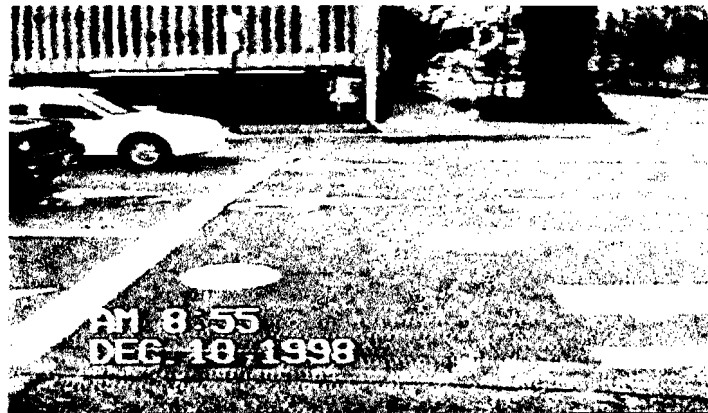
**Figure 11. Enlarged bike box extending across all three lanes of traffic.**

It was determined through observation that the box should be lengthened to promote understanding and visibility by motorists and easier use by bicyclists. This was accomplished by removing about 1 m of the pedestrian crosswalk. The original layout by the paint crew also had lane lines within the box, rather than a large rectangular box in front of two traffic lanes. This was corrected when the box was enlarged, but the result was a box that extended across all three lanes. This was not ascertained until some time later, and the decision was made to leave this configuration in place. Thus, this evaluation pertains to a bike box that extended across all three travel lanes on the street (figure 11).

While the bike box should only have been extended in front of the combination through-/right-turn lane, and not in front of the right turn only lane, bicyclists tended to use the box correctly anyway (i.e., positioning themselves in front of the combination lane). Thus, the evaluation was not jeopardized. (Note: When the evaluation ended, the bike box was reconfigured to extend across only two traffic lanes.)

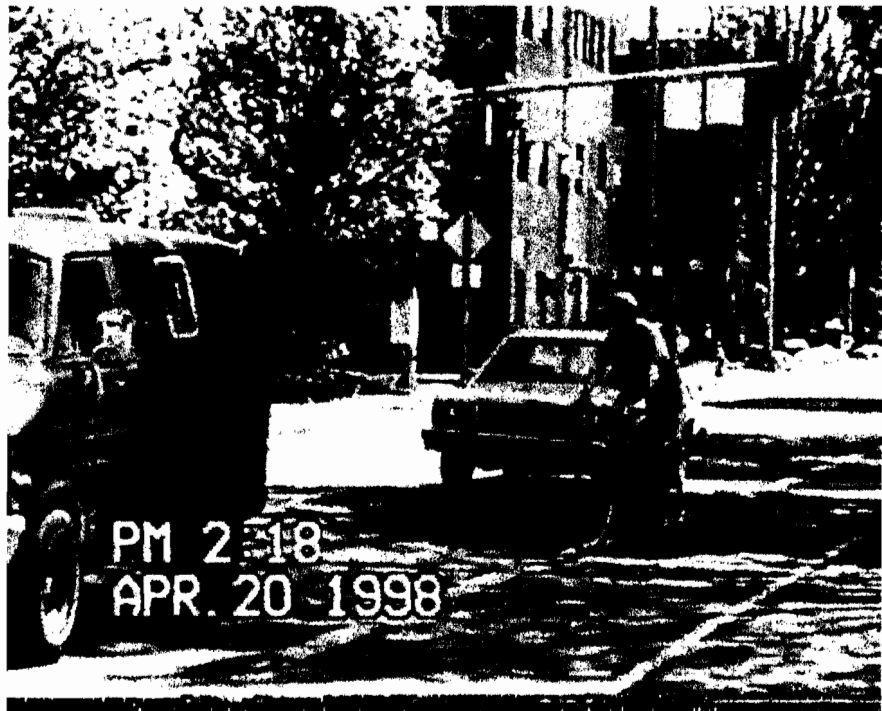
**Figure 14. Bicycle/motor vehicle conflict.**

A conflict between a bicycle and a motor vehicle or another bicycle was defined as an interaction such that at least one of the parties had to make a sudden change in speed or direction to avoid the other (figure 14).

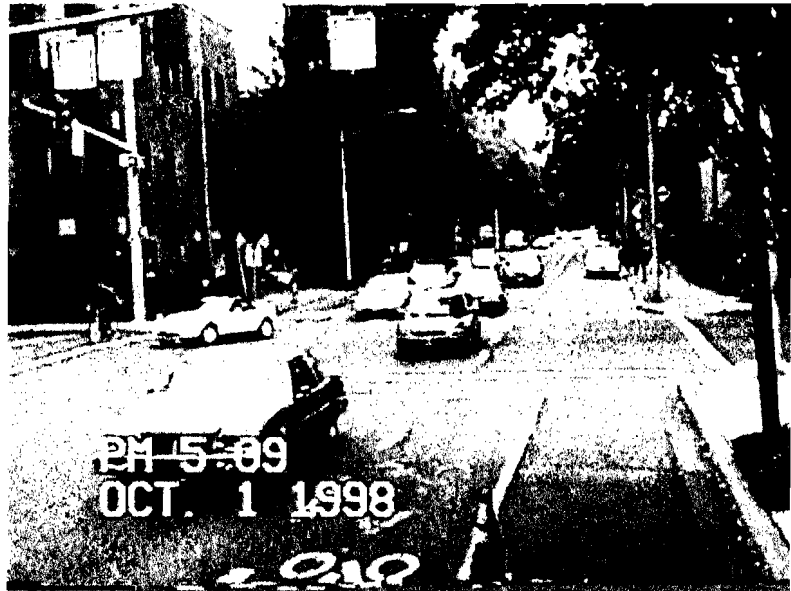
**Figure 15. Conflict when bicyclist comes off right sidewalk into street.**

The location of the conflict was also coded. In the before period, two conflicts occurred within the intersection proper (one while crossing from left to right in the crosswalk and one while approaching from the right in the road) and eight after the intersection. The eight conflicts after the intersection involved the bicyclist crossing from the left-side to the right-side bike lane. In the after period, two conflicts occurred prior to the box, six within the intersection proper, and two after the intersection. No conflicts occurred while using the bike box as intended (i.e., approaching from the left-side bike lane and then moving into the box). It appeared that the bicyclists were able to gauge the timing of the signal quite well. One conflict in the after period occurred when a bicyclist was crossing from left to right in the crosswalk and the signal changed from red to green. Three of the after-period conflicts resulted from bicyclists approaching from the sidewalk on the right-hand side of the street, continuing straight ahead, and then crossing in the Seventh Avenue pedestrian crosswalk. This placed the bicyclist in a position where he/she was difficult to see by motor vehicles making a right turn, particularly motor vehicles turning right from the combination through-/right lane in the middle (figure 15).

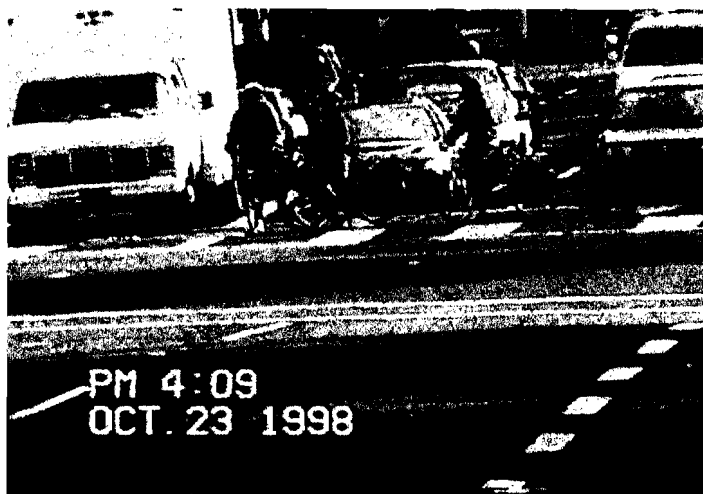
Figure 16. Three bicyclists correctly using the bike box.

In summary, the bike box is a promising tool to help bicyclists and motorists avoid conflicts due to certain kinds of intersection movements (figure 16). More boxes need to be installed and evaluated to further enhance their effectiveness in different settings. Pilot testing the Danish treatment of recessed stop bars for motor vehicles is also recommended.
